TEST REPORT

Fire resistance test of a partially loaded double stud wall system clad each side 35mm Benex panels tested in accordance with AS 1530.4 – 2005.

26704300

28th October 2013

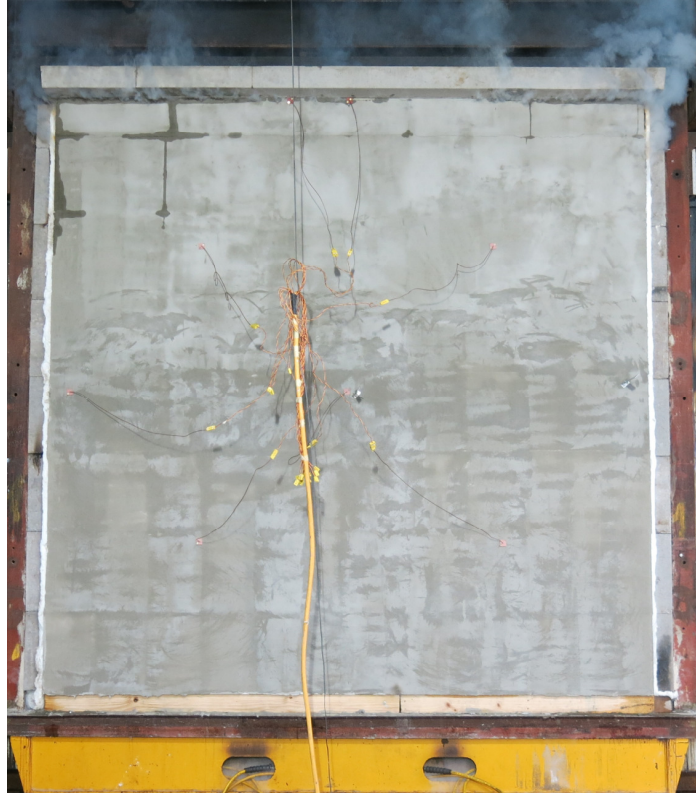
| Time | | Observation |
|---|---|--|
| 63 | 30 | It had become evident that large gaps appeared on both top corners. Flaming had become evident from the top corners of the specimen for more than 10s. Failure on integrity in accordance with AS 1530.4-2005, clause 2.12.2.4, due to sustained flaming on the non-exposed side for greater than 10 seconds. |

Figure A6.3. Unexposed face of specimen at the end of the test

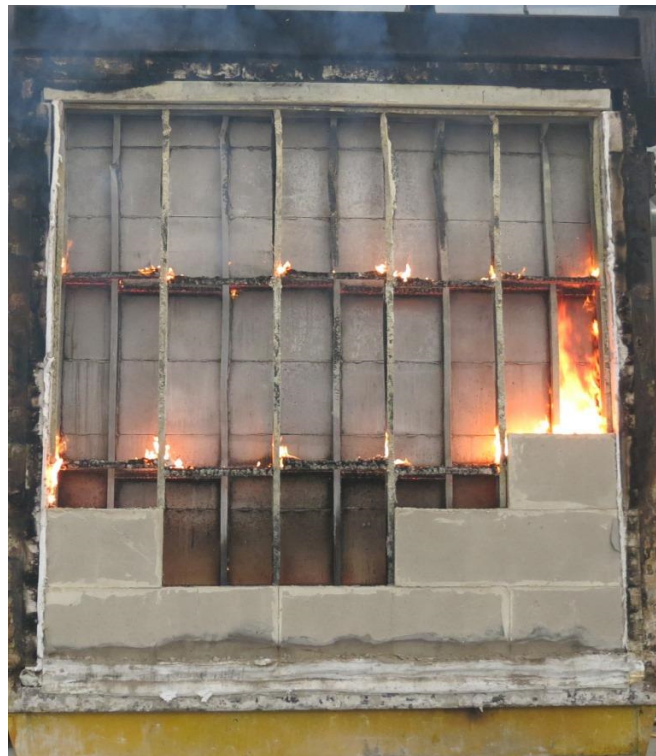
| Time | | Observation |
|---|---|--|
| 10 | 00 | It had become evident that part of the render on the exposed side had spalled and detached from the specimen |
| 41 | 00 | It had become evident that cracks appeared on render at the horizontal and vertical joint of the panel on the exposed side |

Figure A6.4 Exposed face of specimen at the end of the test
