Benex – Resistance to Water Penetration

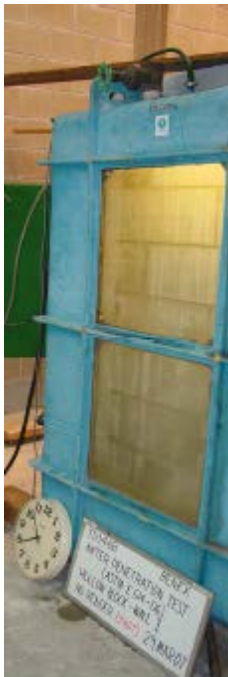
Benex however has been independently tested by the CSIRO* using ASTM 514-06 and found to pass this water permeability test for more than 24 hours

One single leaf test panel was built from the 200mm hollow Benex blocks. The panel was constructed in the laboratory and was approximately 1800mm high x 1200mm wide. The test panel was built by an experienced block/brick layer using the Benex thin-bed mortar.

The test apparatus enclosed an area 1070mm x 1600mm on the test face of the panel. The test chamber was positioned on the specimen and clamped firmly in place, compressing a rubber seal which prevented any loss of water and air pressure

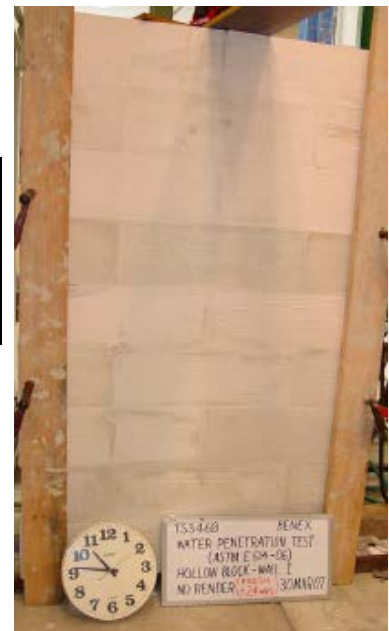
The results from this testing showed the Benex 200mm hollow wall, resisted water penetration through the masonry element to the rear face of the test wall.

Hence, it may be concluded that properly built Benex masonry walls can resist the conditions imposed by the ASTM water permeability test for more than 24 hours, without failure. In general, rendered Benex masonry walls can be considered as impervious without further protection since any tiny holes in the mortar joints can be fully covered by the render.
